## AVIATION INVESTIGATION REPORT

A01P0061

### MAIN-ROTOR BLADE FAILURE

MD HELICOPTERS 369D C-GHFL

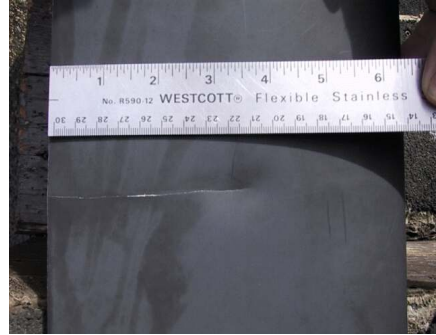
After the occurrence, company maintenance personnel inspected the blades and found that one of the five blades—part number 369D21100-523, serial number 009999-K077, the blade colour-coded yellow—had cracked at the upper and lower skins, from the trailing edge to the spar.

Figure 1 - Cracked blade

1. The main-rotor blade failed because its structural integrity was compromised by a manufacturing defect at the edge of a lightening hole in the C-channel, internal to the blade, located about three inches inboard of the data plate.
2. The defect at the lightening hole resulted in a fatigue crack that propagated to the lower skin, rearward to the trailing edge, and around to the top skin going forward in the direction of the blade spar.

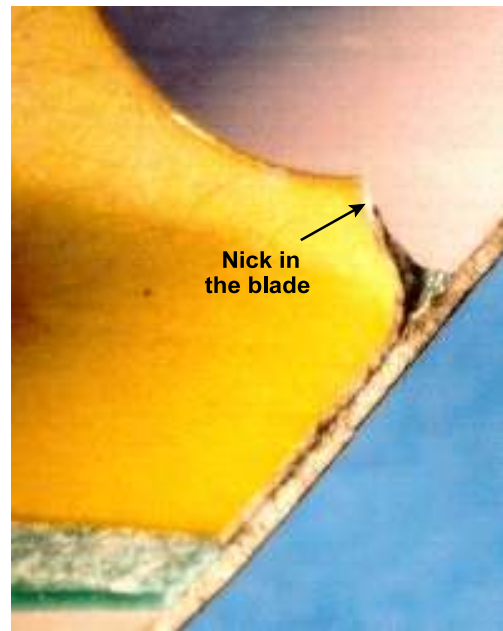
The failed blade was examined visually and using X-rays, photography, scanning electron microscope, and optical microscope. The examination revealed a fatigue failure and crack that started from a nick or rough radius on the edge of a lightening hole on the C-channel structure of the blade, about three inches inboard of the data plate. The fracture propagated to the top and bottom skins of the blade and subsequently across the cord of the blade, causing a separation at the trailing edge. The fractures stopped at or near the 'D' spar structure near the leading edge of the blade.

Figure 2 - Lightening hole

A nick or inclusion, in the radius of a lightening hole on the C-channel, was introduced at manufacture and compromised the structural integrity of the main rotor blade. This nick caused a stress riser and was the origin of a crack that propagated to the blade's lower skin, trailing edge, and onto the top skin perpendicular to the span of the blade, where the crack stopped near the blade spar. A recent inspection of the blade by company maintenance failed to detect any damage or crack; this suggests that crack propagation may develop rapidly and be difficult to detect.

MDHI no longer manufactures main-rotor blades for 500-series helicopters. Under parts manufacturing approval, Helicopter Technologies Corporation (HTC) now assures the supply of these blades. HTC has incorporated an ultrasonic inspection as part of its manufacturing process to check for subsurface defects, voids, and cracks that, if undetected, may affect the structural integrity of the blades.
